### Case History

# Identification of a unique vibration problem

by Jim McDowell

and Peyton Swan, P.E.

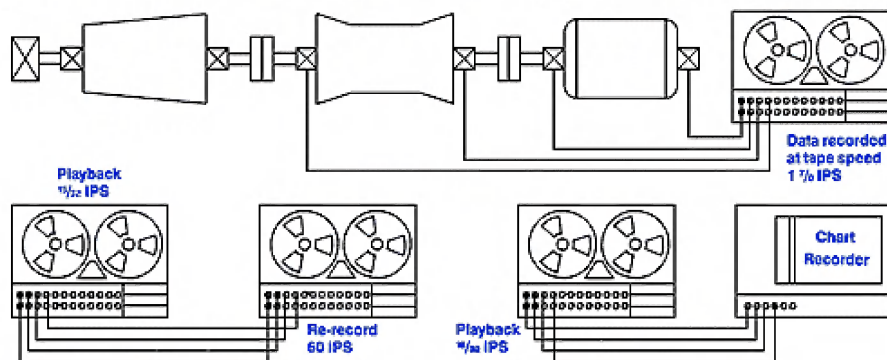
Process used to slow the event for analysis.

Figure 3 illustrates the process used to slow the event down enough to be analyzed. The data was played back at 15/32 in/sec, and re-recorded on a second tape recorder at 60 in/sec. This new tape was then played back at 15/32 in/sec (512 times slower than the original speed) to an analog chart recorder and a camera-equipped oscilloscope. One revolution of the shaft now took 8.533 seconds — long enough for an accurate documentation to indicate which signal was changing first.
